## Chateaugay Lakes invasive plant control project

### Work Summary: Week 1 (June 10<sup>th</sup> - 13<sup>th</sup>) 2013

### Work Summary: Week 2 (June 17<sup>th</sup> - 20<sup>th</sup>) 2013

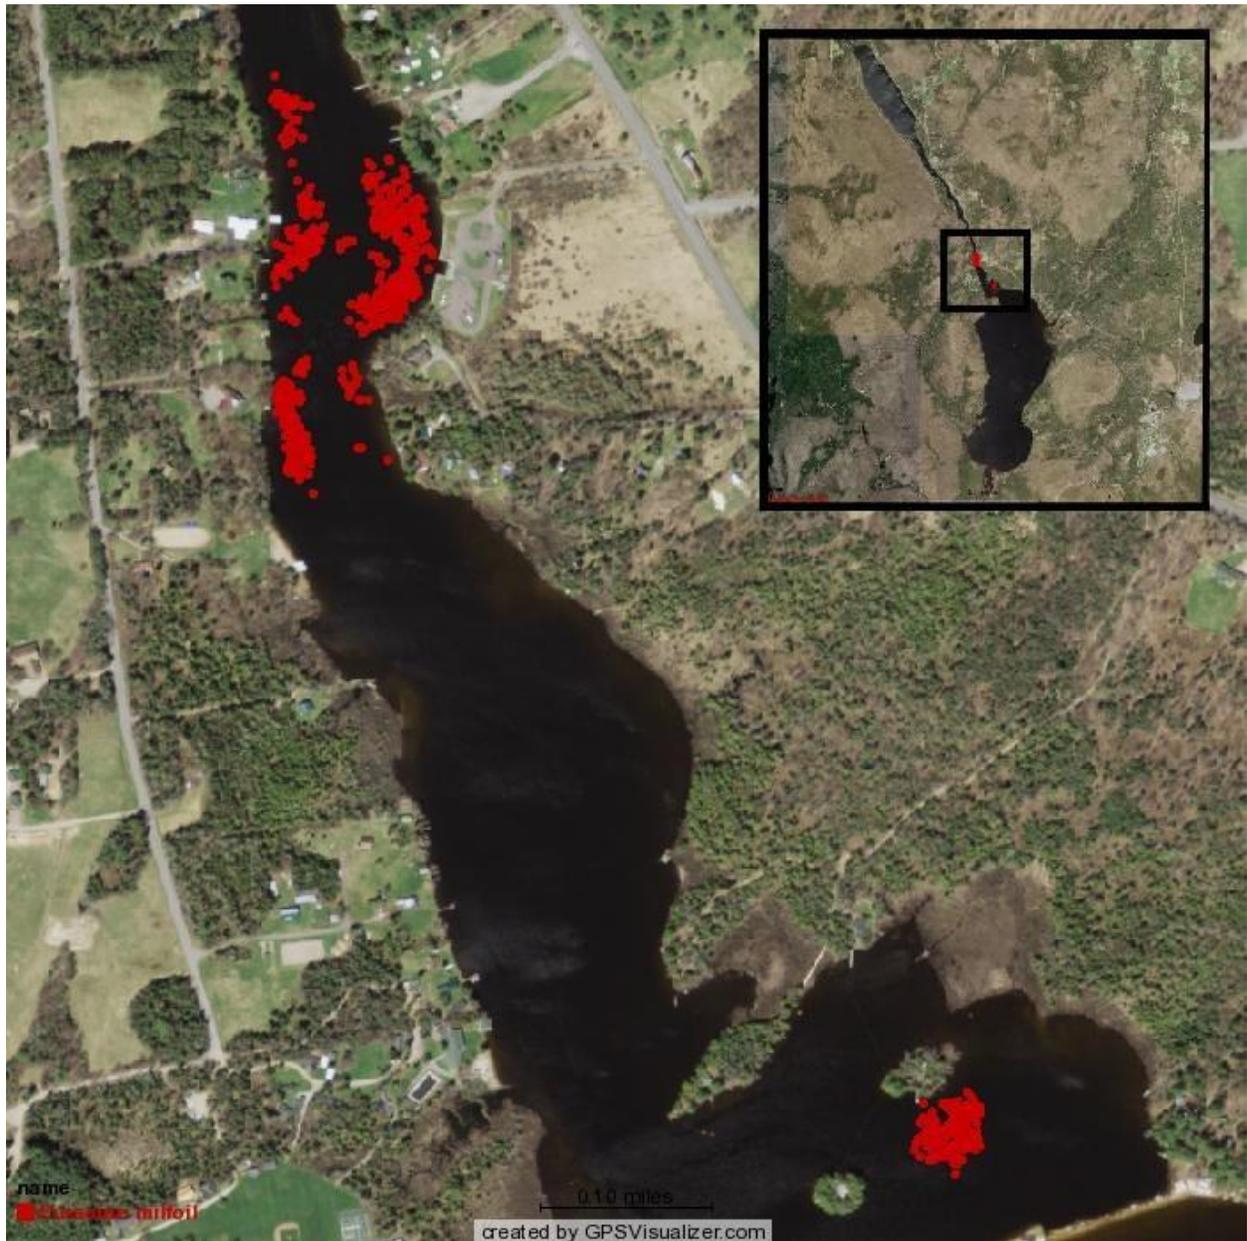
### Eurasian Milfoil Harvest Map

Started the week diving the north entrance of the boat launch beds harvesting 40 bags. A small amount of Curly Leaf Pondweed was found mixed in with the milfoil. Although conditions were very murky the area seemed to be in better shape than past years. Plants are becoming more and more sporadic. Further maintenance will be necessary to prevent it from becoming a problem area again.

Continued working the boat launch area with a focus on the south entrance area. On this side we harvested another 35 bags. The same goes for this area as the north area. Plants are more sporadic than past years and the area will need to be maintained.

Swam the western side of the narrows across from the boat launch known as transect areas 1 and 2 on the map. In this area 48 bags were harvested mostly in a dense patch just north of the girl's camp.

Did a cleanup swim of the western side of the narrows that was worked the day before. After the area was determined to be in good shape we moved to the eastern shore just south of the boat launch. Between the two areas 14 bags were harvested. In the afternoon we moved to the sandbar area. Here, extremely dense beds of milfoil were swam. In a short time at the end of the day 31 bags were pulled from the area. This site should be a priority for the following week.

**Weekly Bag total:      167 bags      4,175 pounds**

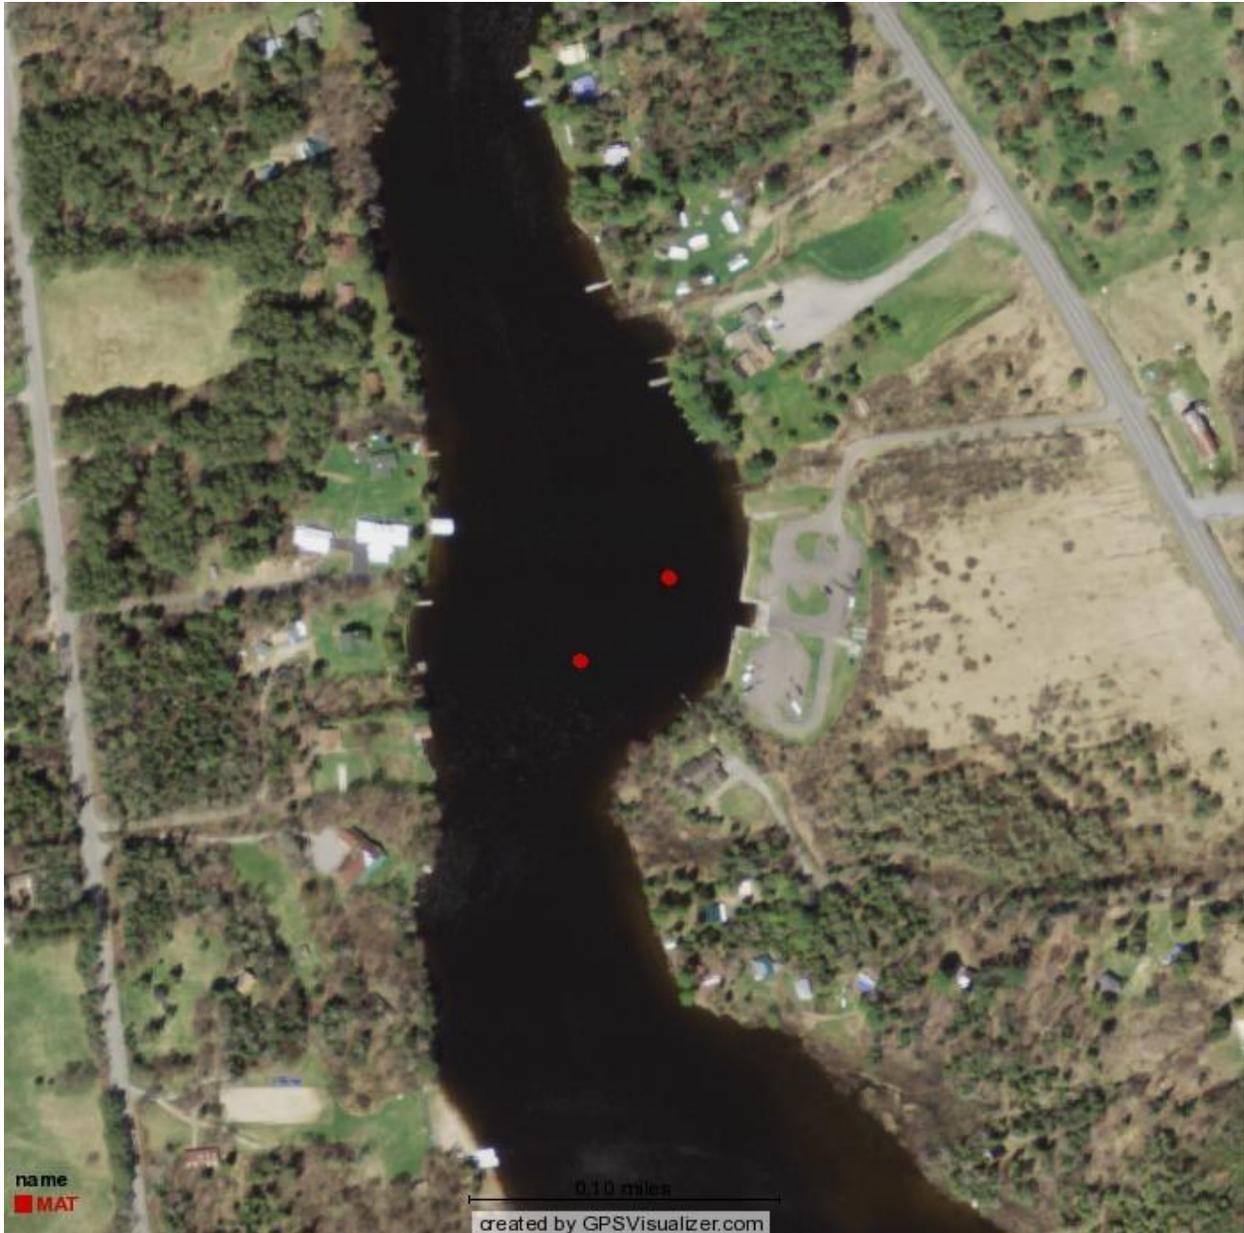
## Week 1: Benthic mat locations map and coordinates

Below is a map of the waypoints indicating benthic mats found while conducting hand harvesting during the week of June 10<sup>th</sup>, 2013.

These are the actual coordinates of the mat locations.

<u>name</u>	<u>date</u>	<u>lat</u>	<u>long</u>
MAT	6/10/2013 12:55	44.77389	-73.9806
MAT	6/13/2013 11:22	44.7735	-73.9812

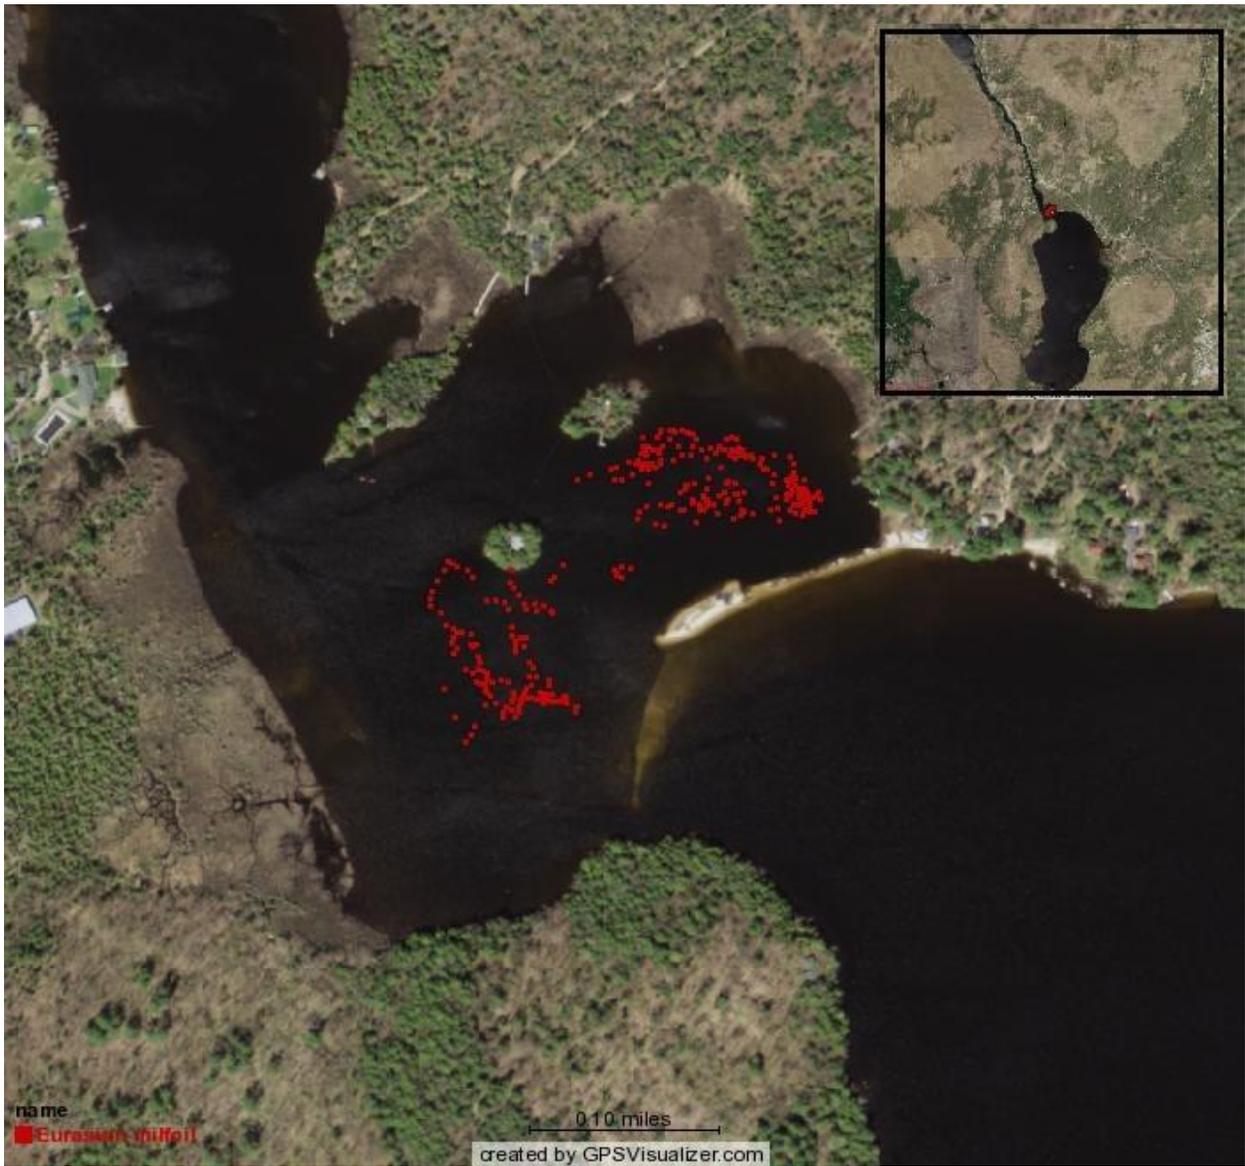
### Eurasian Milfoil Harvest Map

**Started working the bay between the inner island and sandbar. Here a few dense beds were found and harvested. 60 bags were pulled. Area will need clean up swim in the future.**

Continued working the dense beds in the sandbar area, Harvesting another 62 bags from the area. Plants ranged from young single stems to sixteen stemmed dense old growth plants.

Continued working the sand bar beds with a focus on cleaning up the areas that were harvested the previous two days. Area was looking better with 39 bags removed. Most of which were scattered plants that were missed due to poor visibility.

Moved to the outer edge of the bay toward the boating lane where we found the milfoil to be scattered in places and dense in others. By swimming around the area we determined that near the outer island had been worked in the past. 42 ½ bags were harvested from the area. This should be a priority for next year.

**Weekly Bag total:      203.5 bags      5,087.5 pounds**

The sand bar area is starting to look much better, however I believe that it should be swam first thing next year to prevent new growth. The area I would recommend starting would be just north east of the channel were we left of picking a very dense bed of old growth milfoil.

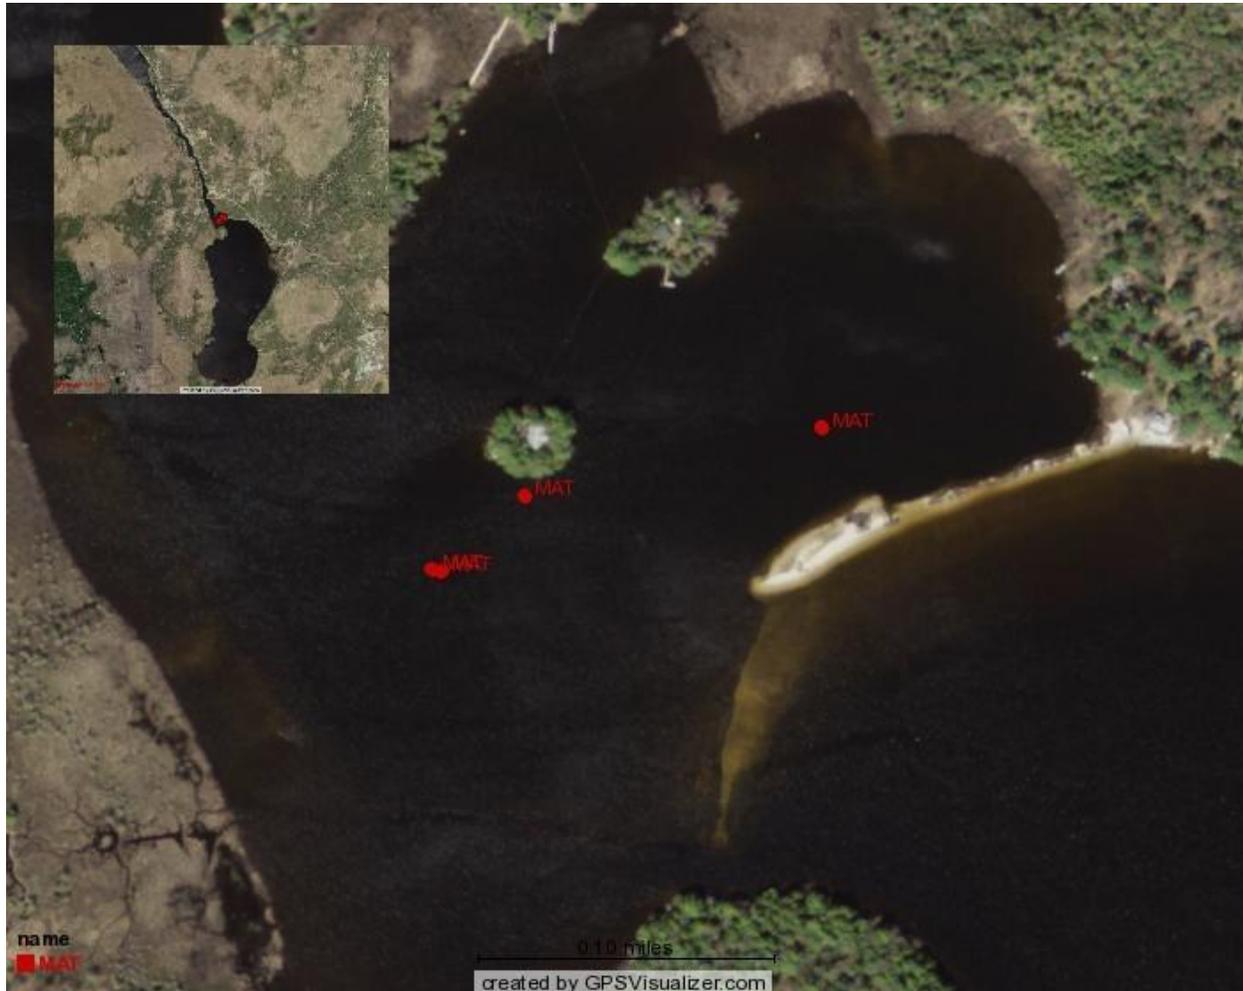
## Week 2: Benthic mat locations map and coordinates

Below is a map of the waypoints indicating benthic mats found while conducting hand harvesting during the week of June 17<sup>th</sup>, 2013.

These are the actual coordinates of the mat locations.

<u>name</u>	<u>date</u>	<u>lat</u>	<u>long</u>
MAT	6/17/2013 13:14	44.76594	-73.97332
MAT	6/20/2013 9:14	44.76523	-73.97595
MAT	6/20/2013 10:06	44.76524	-73.97602
MAT	6/20/2013 12:30	44.7656	-73.97537
